ENGINE BORESCOPE REPORT

CESSNA AIRCRAFT SERVICE CENTER **ESN PK2531**

ENGINE BORESCOPE INSPECTION REPORT

SERVICE ORDER : 6111981448 ENGINE MODEL : PT6A-60A ENGINE SERIAL NUMBER : PCE- PK2531

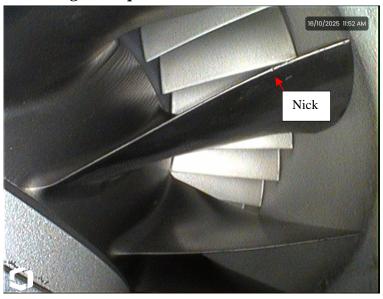
First Stage Compressor

General view on leading edge of First Stage Compressor. Minor nicks observed, serviceable as per MM.

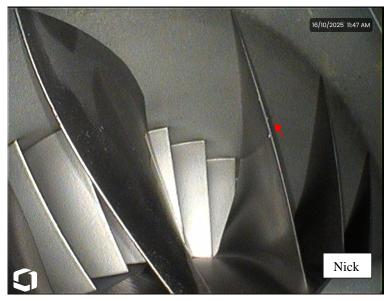
General view on leading edge of First Stage Compressor.

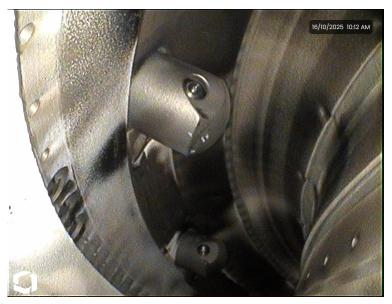
Combustion Chamber Liner & Small Exit Duct

General view on leading edge of Combustion liner.

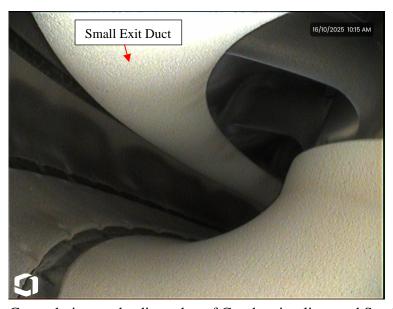
General view on leading edge of Combustion liner and Small Exit Duct.

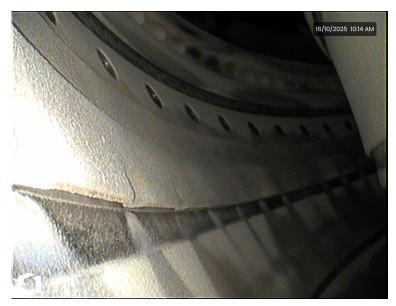
Combustion Chamber Liner & Small Exit Duct

General view on leading edge of Combustion liner.

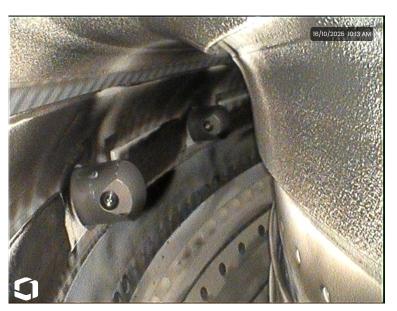
General view on leading edge of Combustion liner.

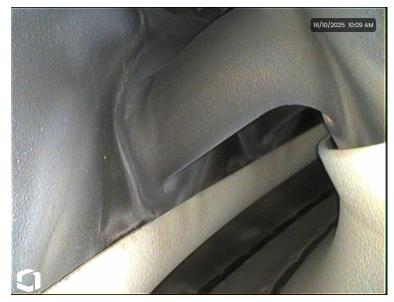
Compressor Turbine (CT) Vane

General view of CT Vane leading edge.

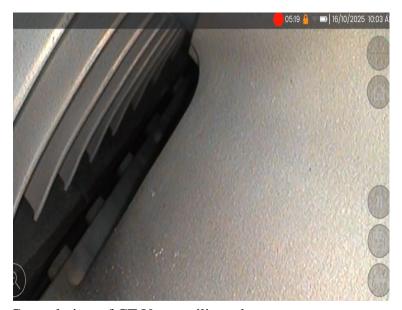
General view of CT Vane trailing edge.

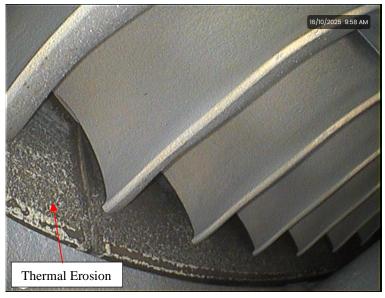
Compressor Turbine Blades and Segments

General view of CT blades and Shroud Segments.

Thermal Erosion and rubbing observed on shroud segments, acceptable.

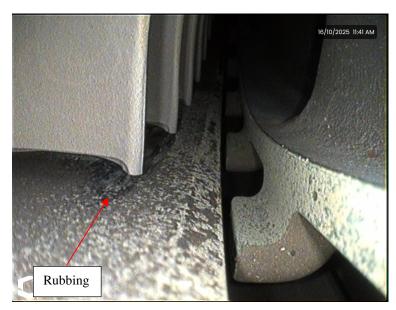
General view of CT blades and Shroud Segments.

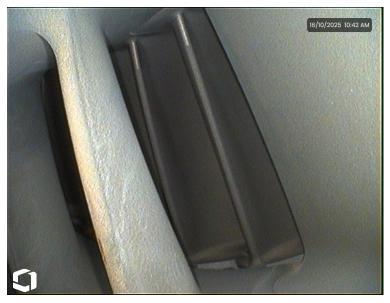
Power Turbine Blades

General view of Power Turbine First Stage Blades and Stator.

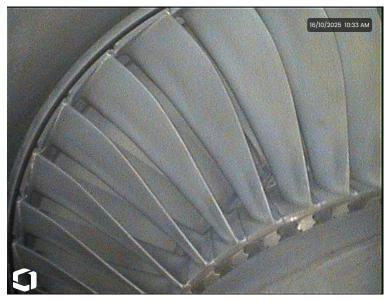
General view of Power Turbine Second Stage Blades.
