King Air Series Inspection Report

Customer: Bramco, LLC

Model: B-200

Serial No: BB-1920

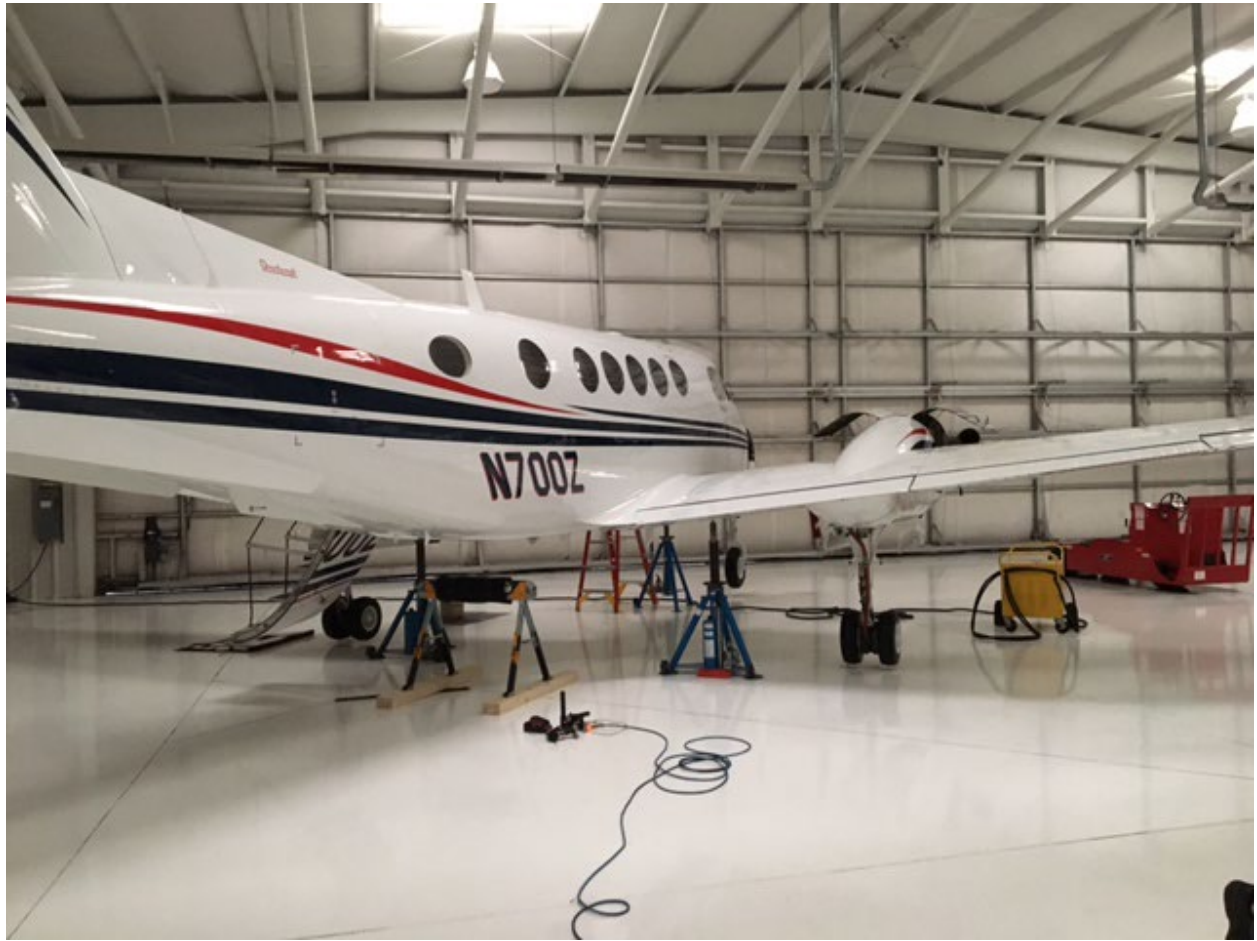
Initial Visit to the Aircraft in March 2017.

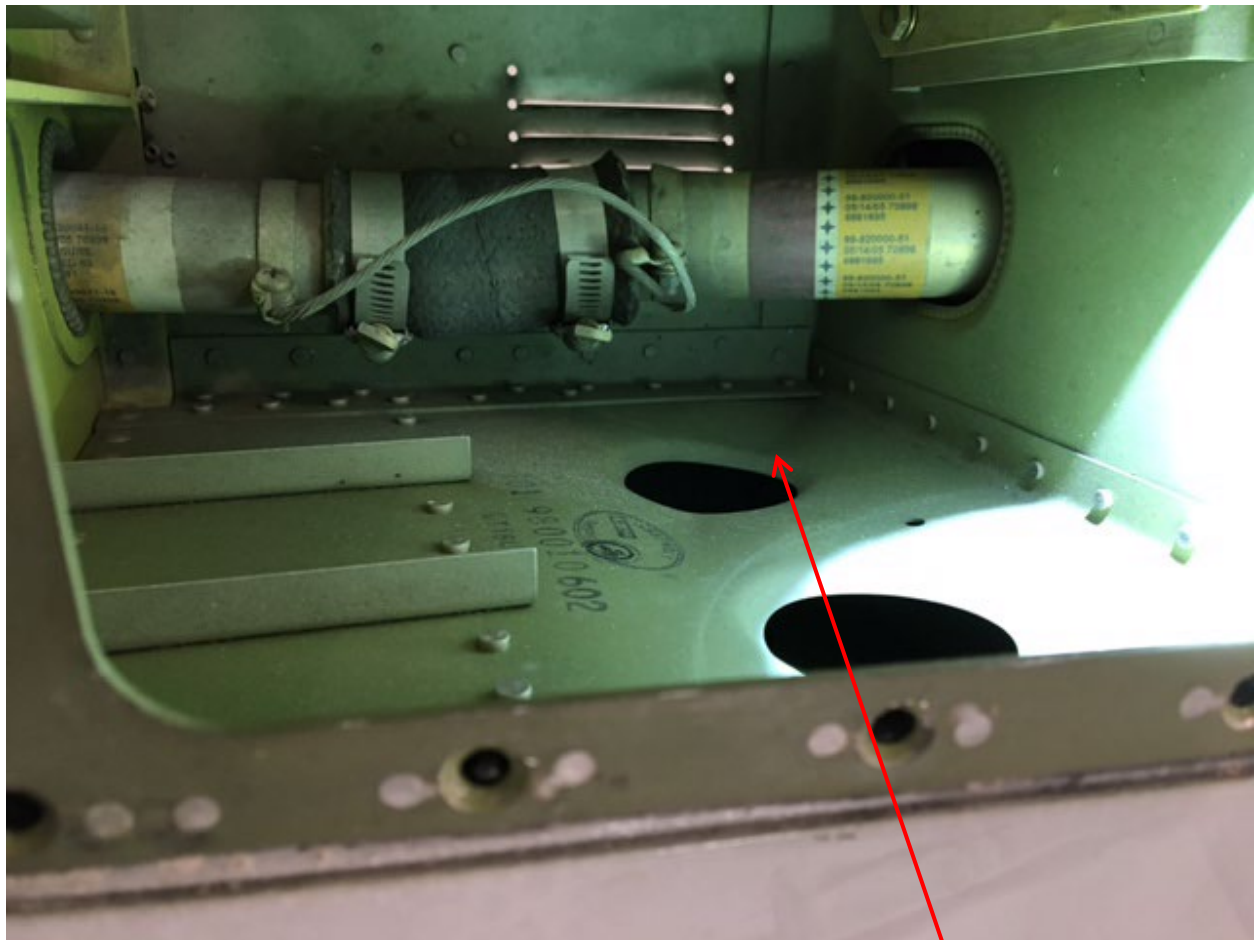
Wrinkled web in Inverter bay area. Replaced.

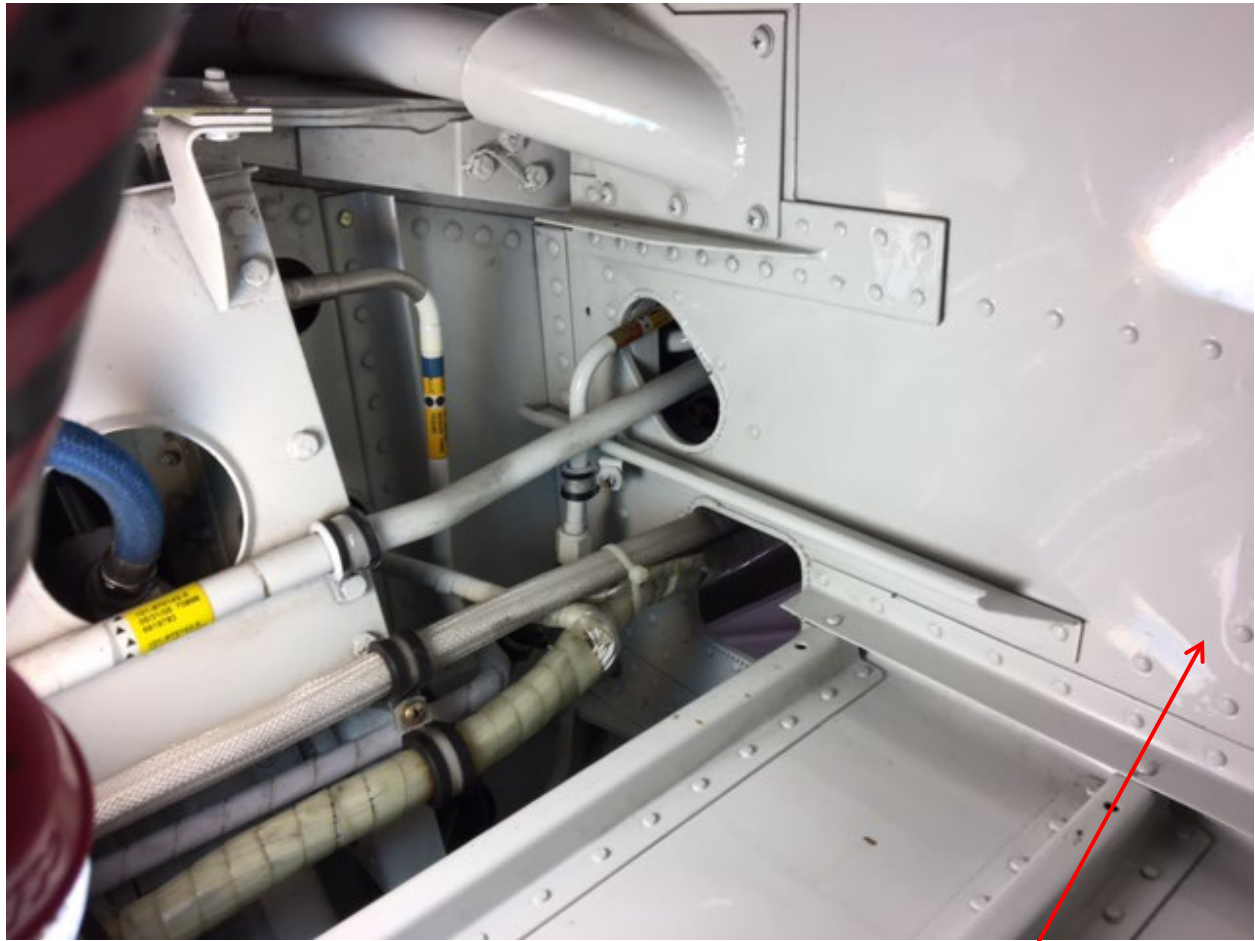
Wheel Well Outboard Keel Wrinkles, RH. Replaced.

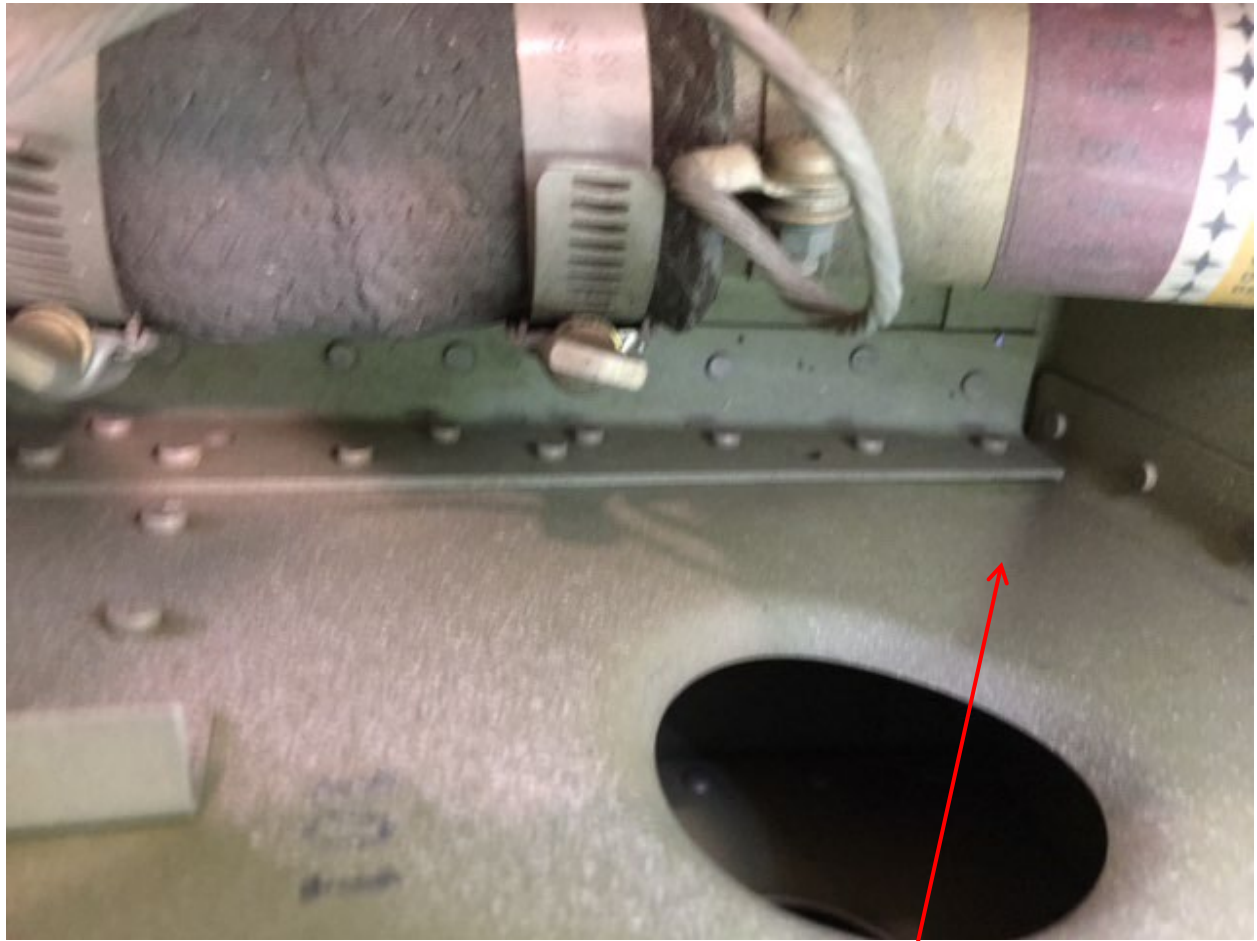
Inverter panel web wrinkle. Replaced.

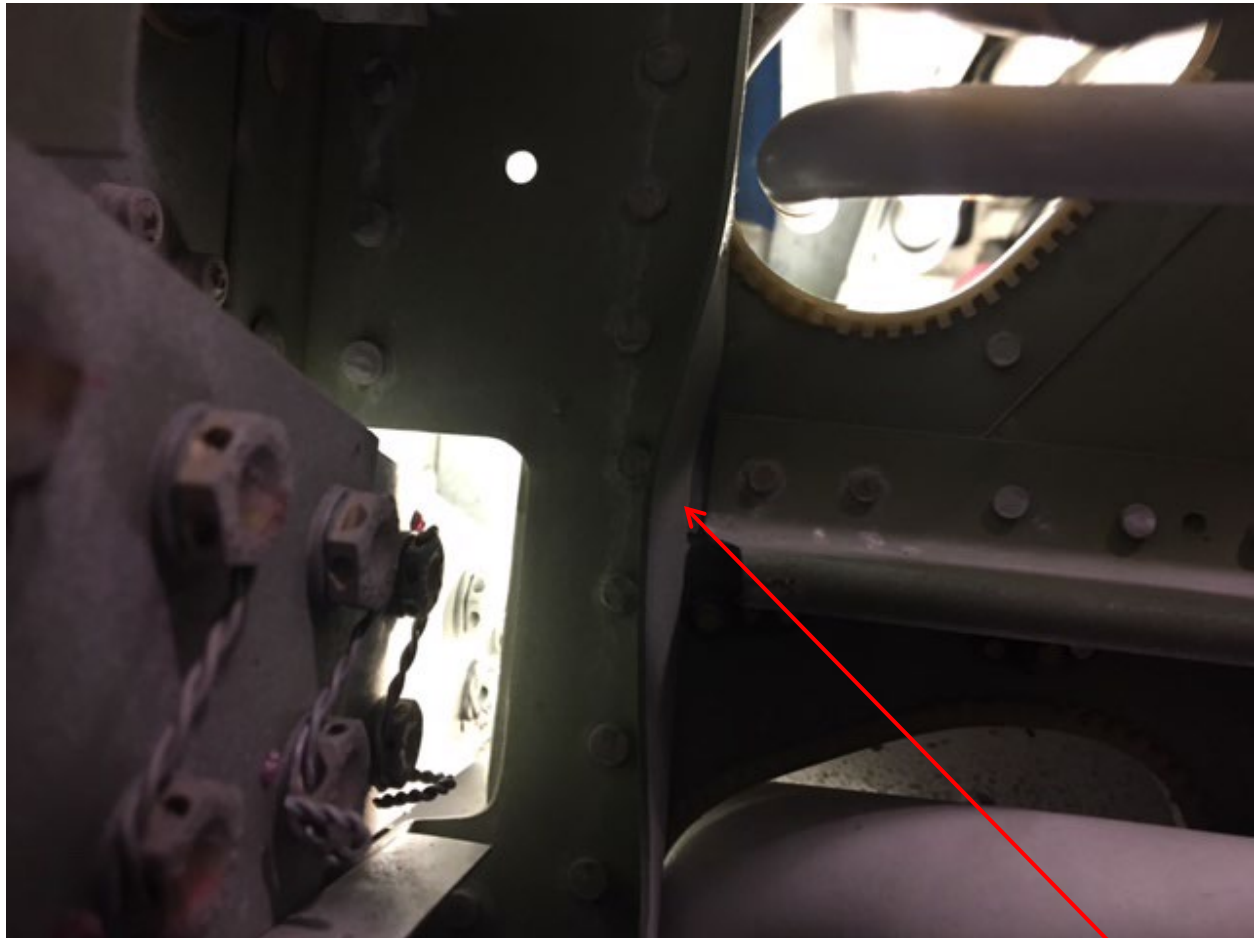
Deformed stiffener where wing attach fitting passes through Keel. Replaced.

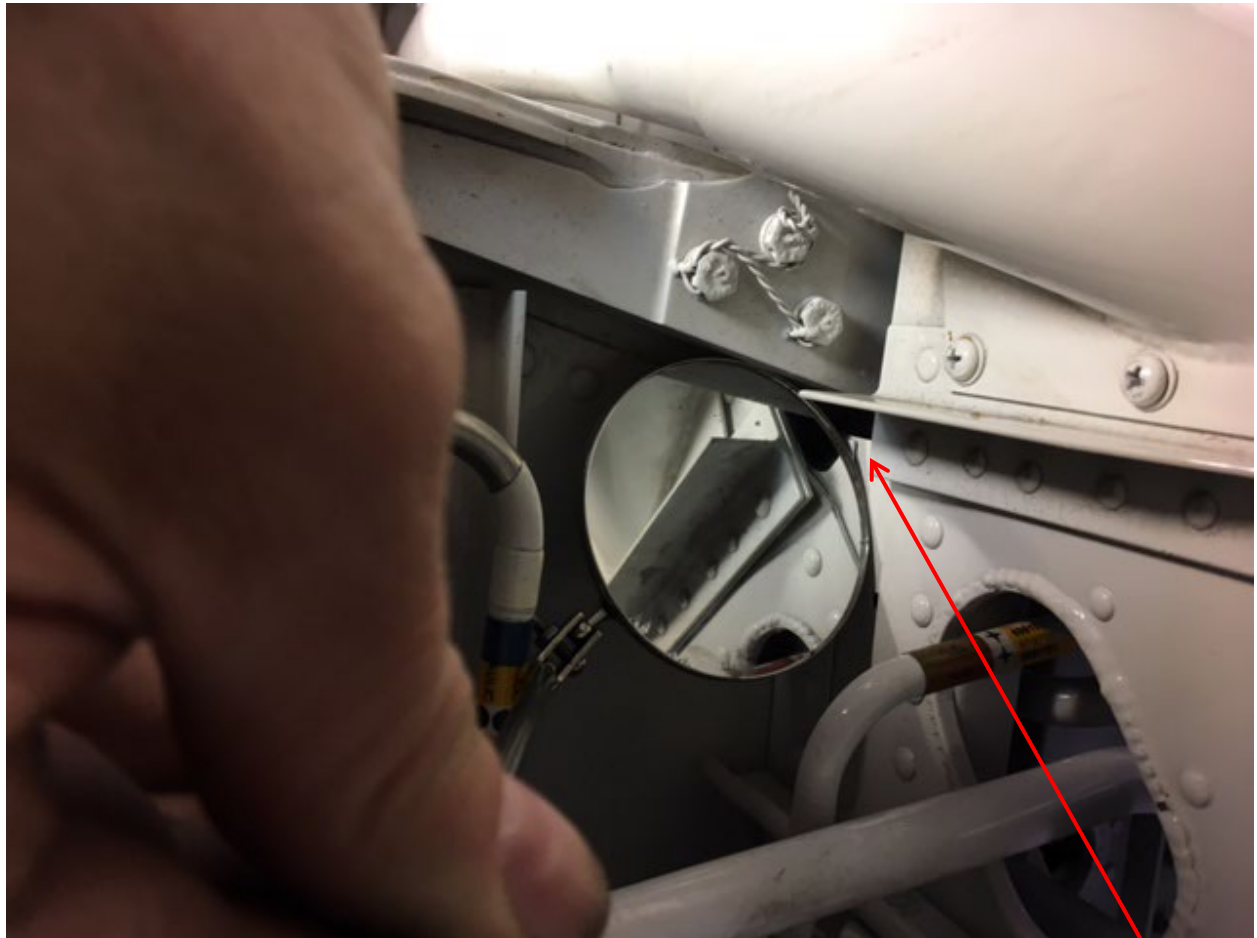
Deformed Structure in wheel well area, RH. Reformed with keel replacement.

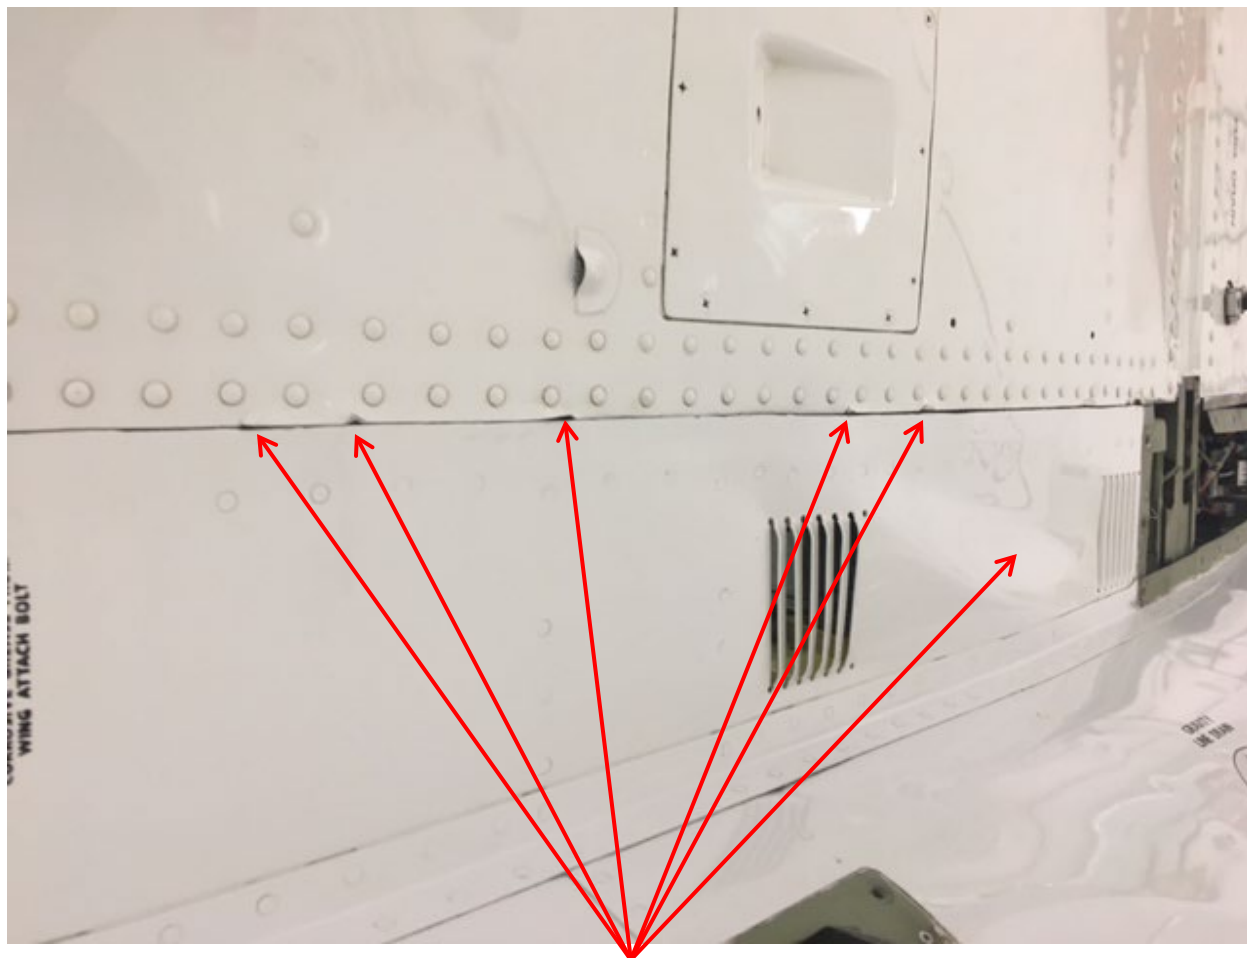
Skin deformation and wrinkles where wing meets center section, Skin on center section was replaced. Skin on wing was re-contoured.

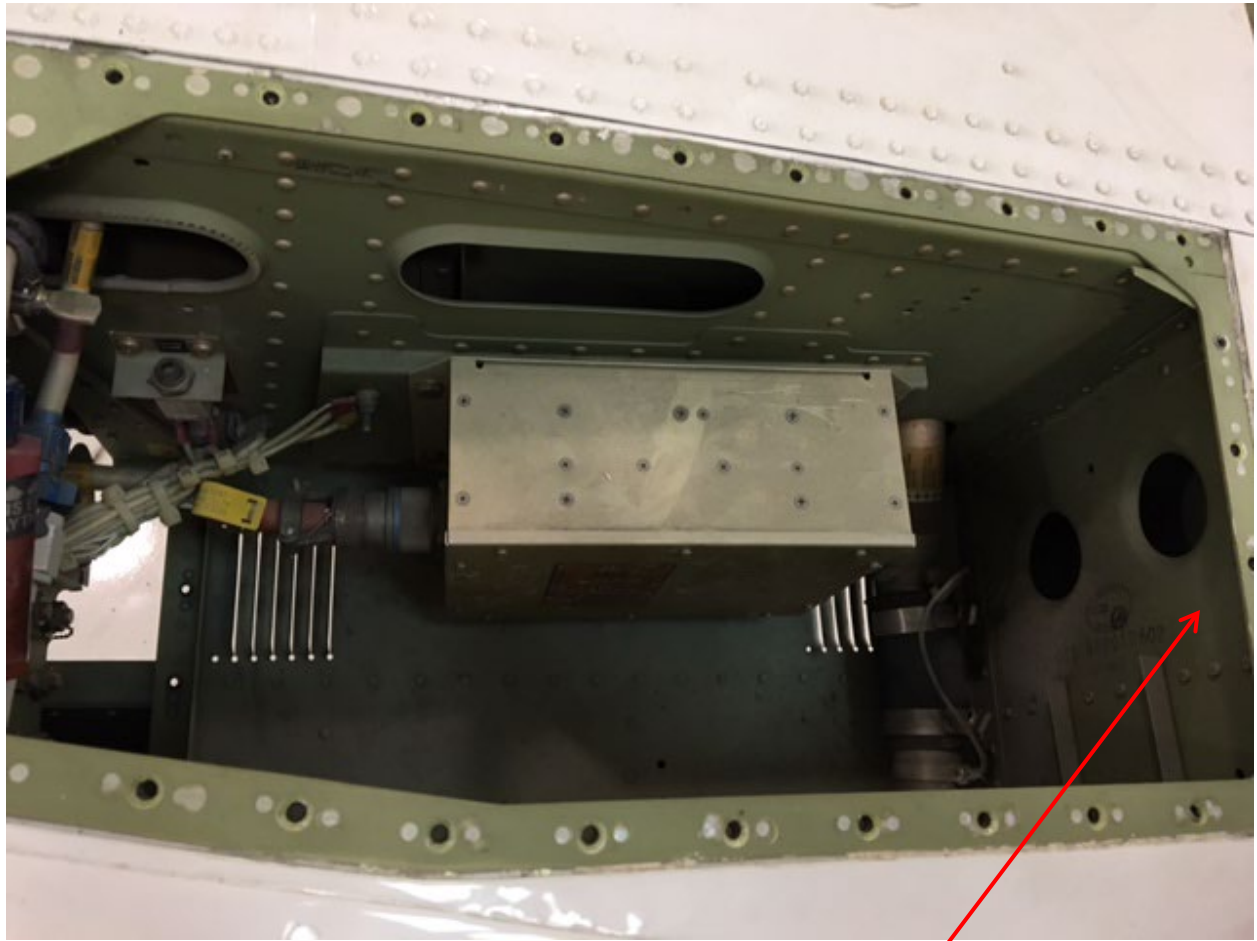
Inverter panel wrinkles. Web replaced.

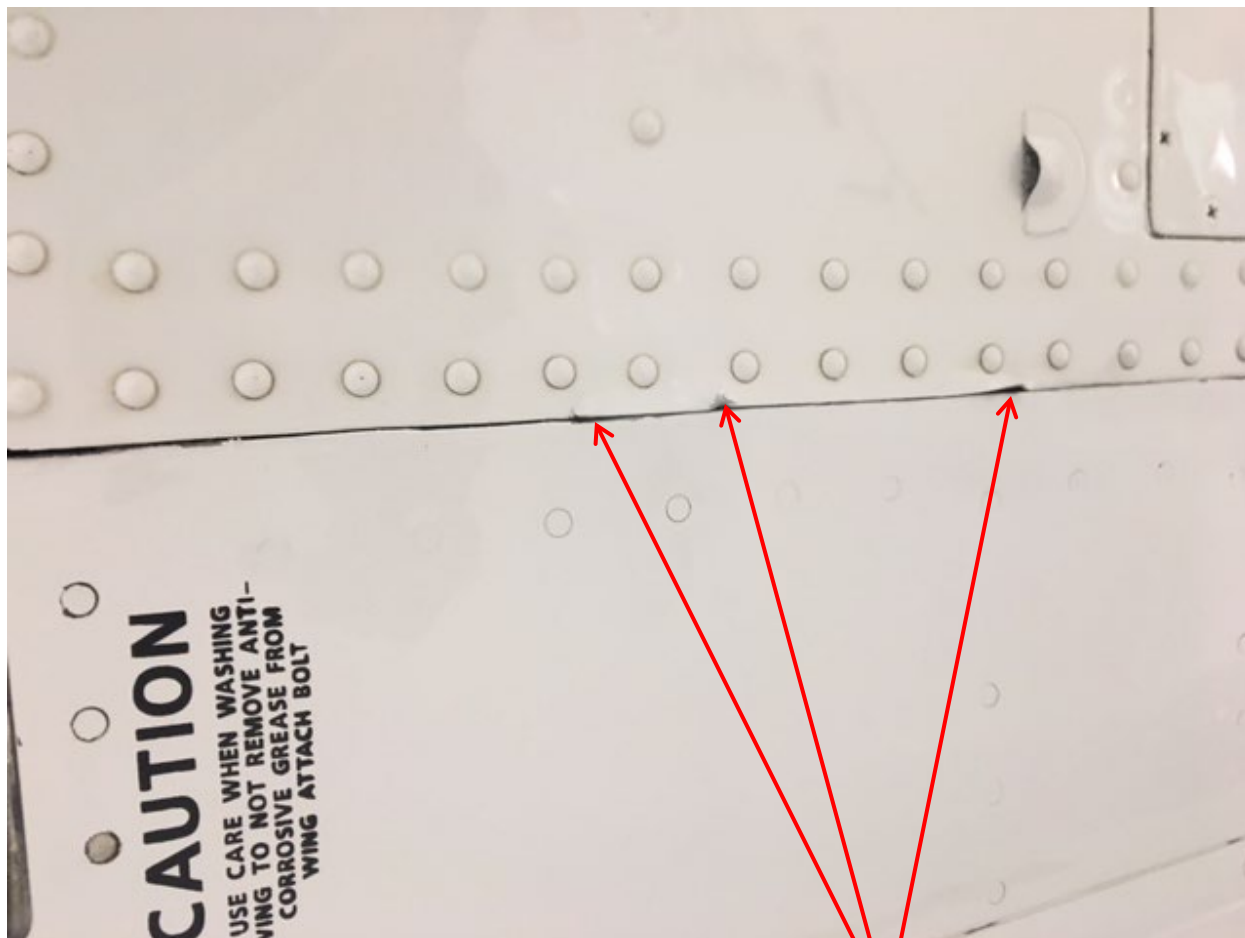
Closer picture of skin deformation.

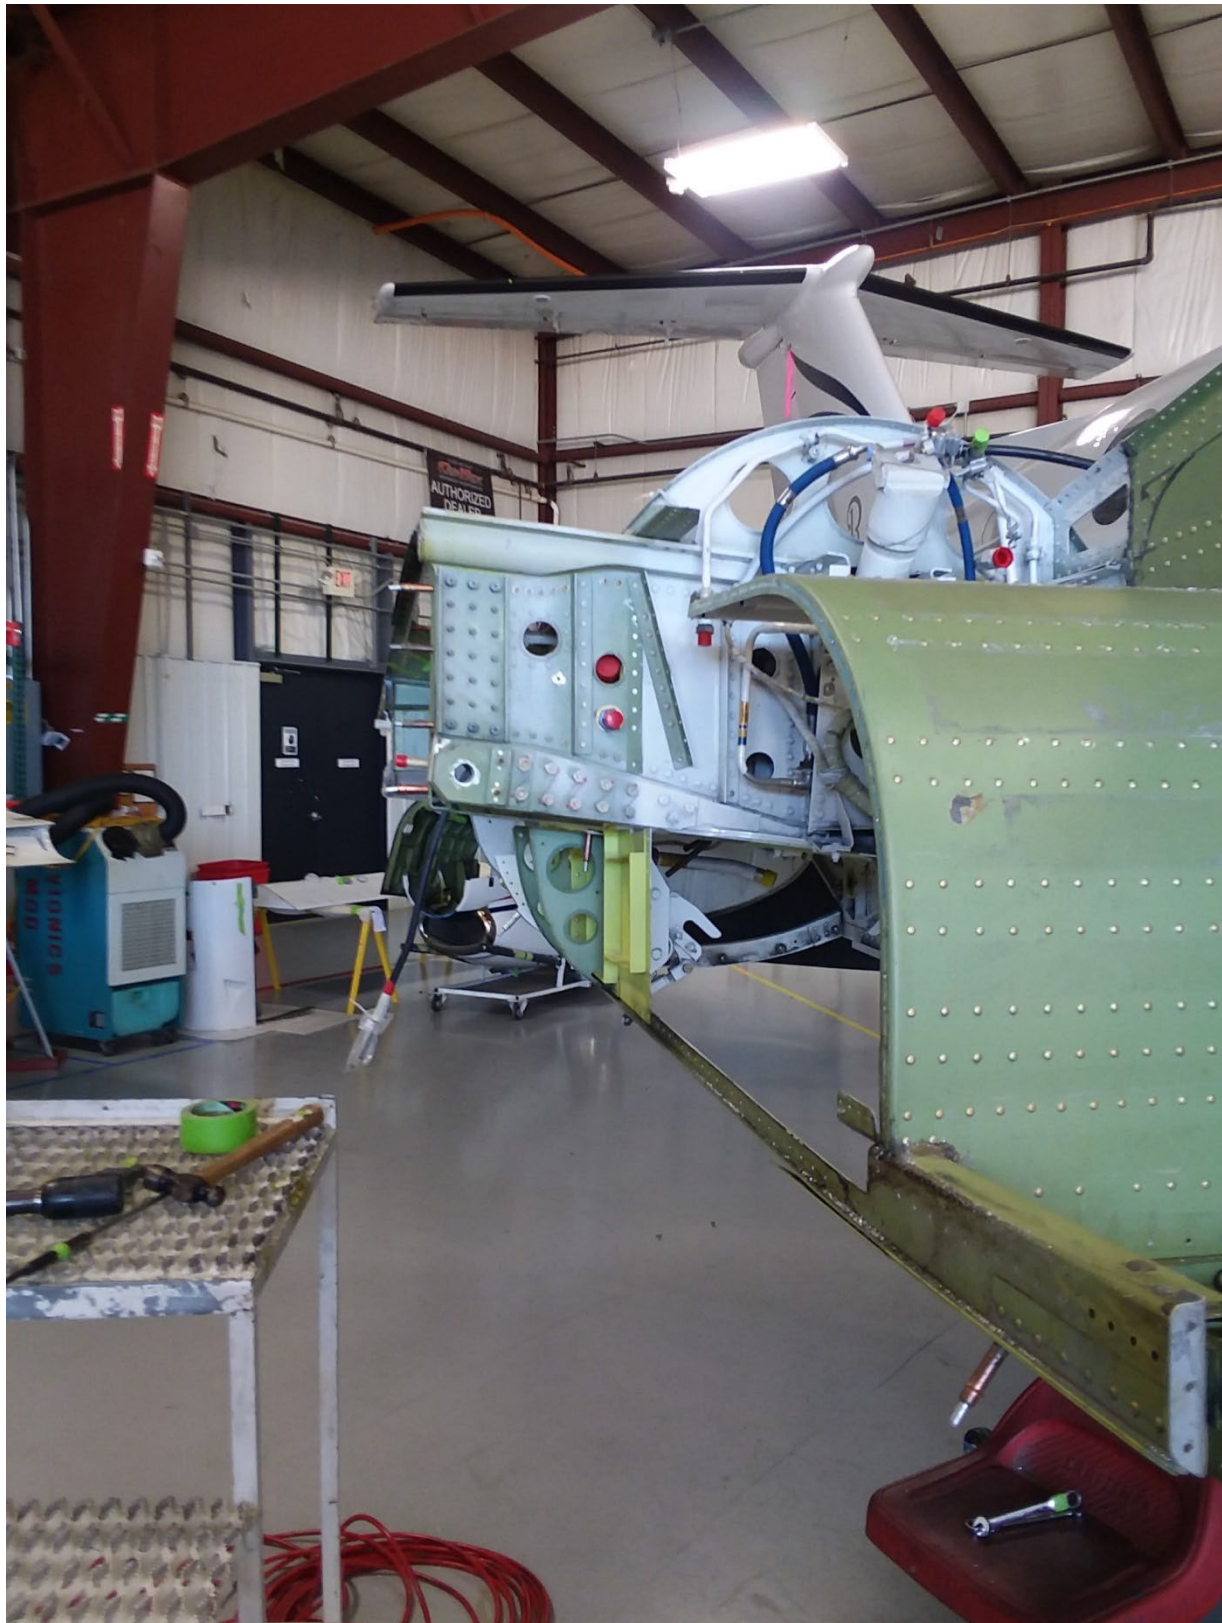
With firewall and keel removed to facilitate keel replacement.

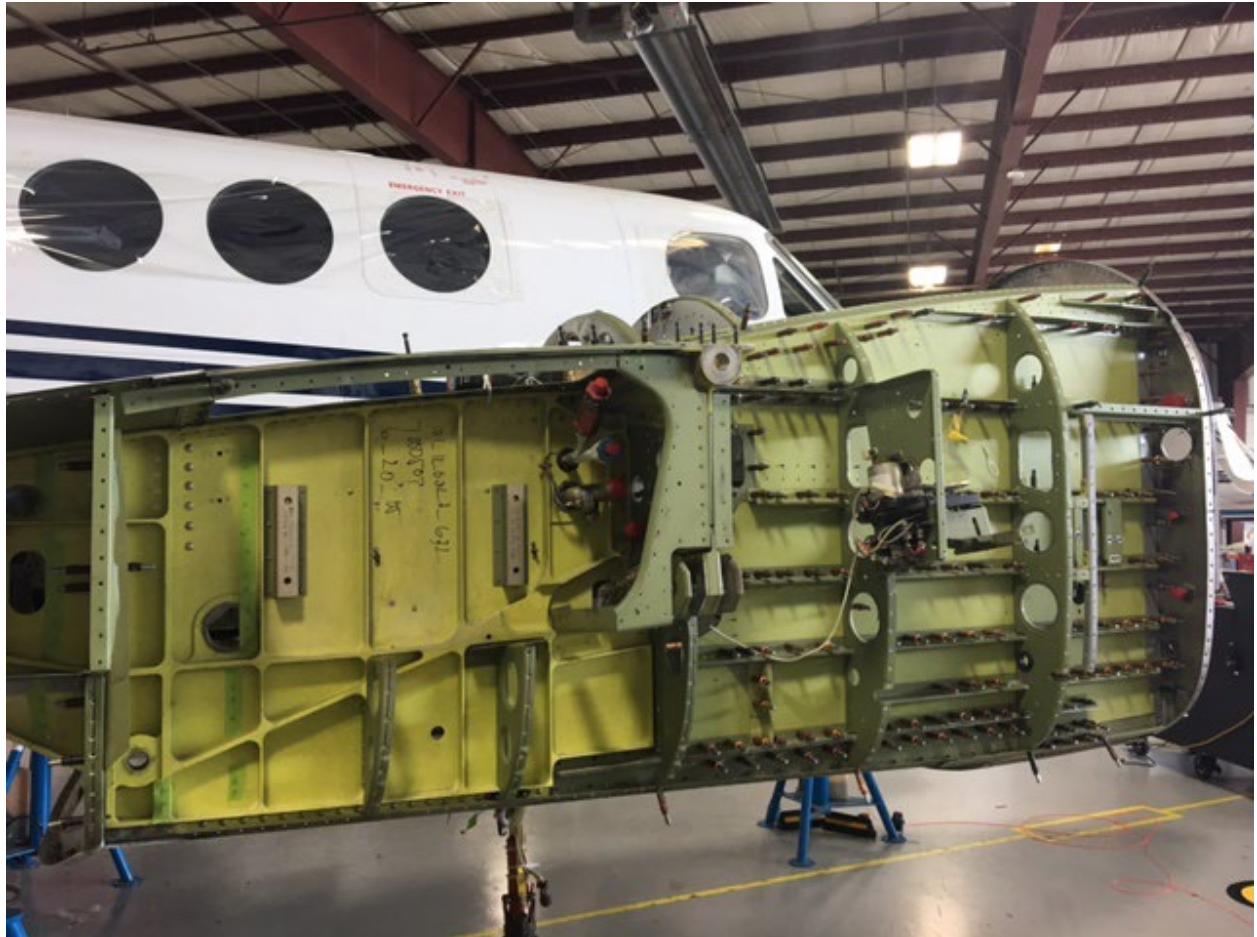
In Progress Picture going back together.

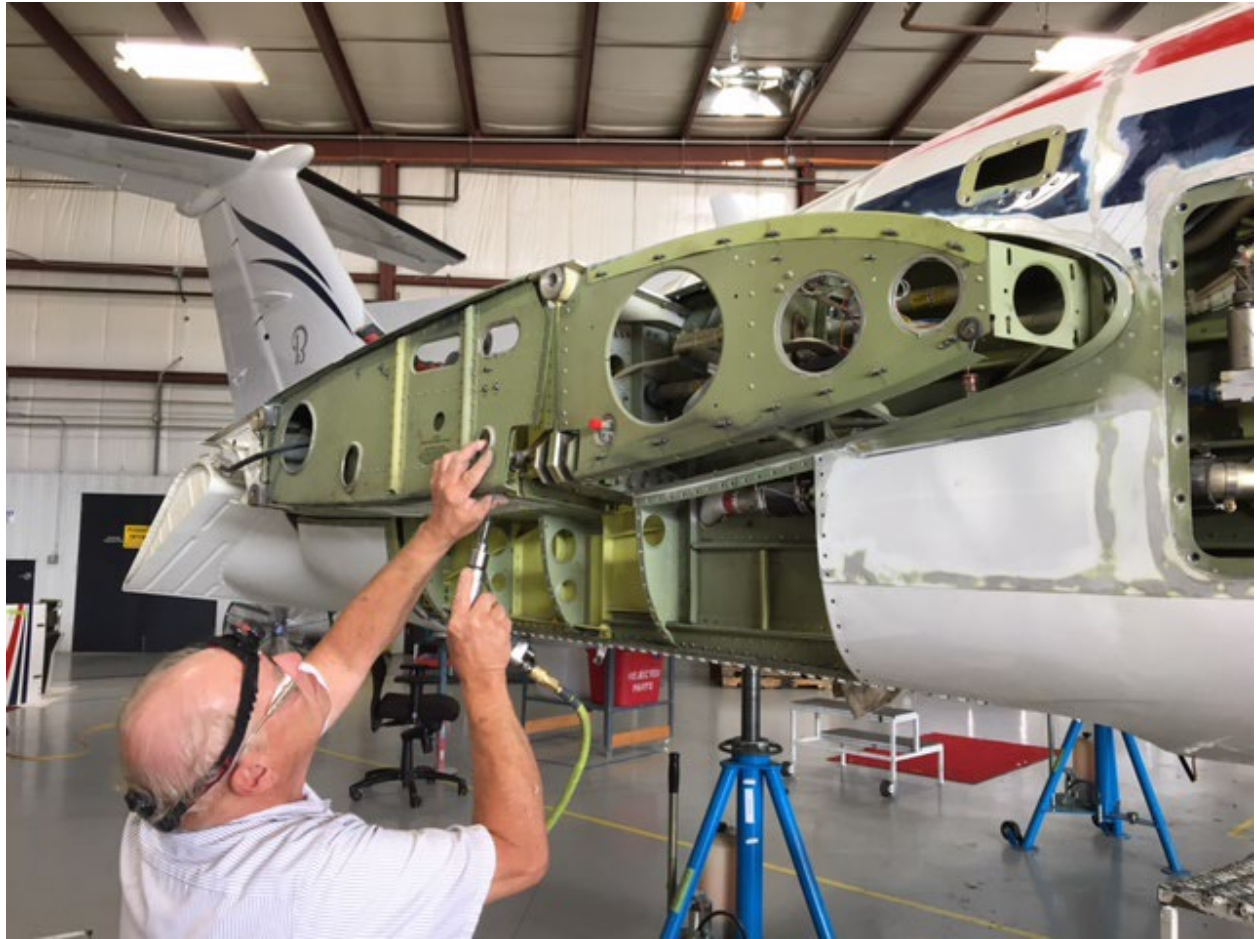
In-Progress Picture.

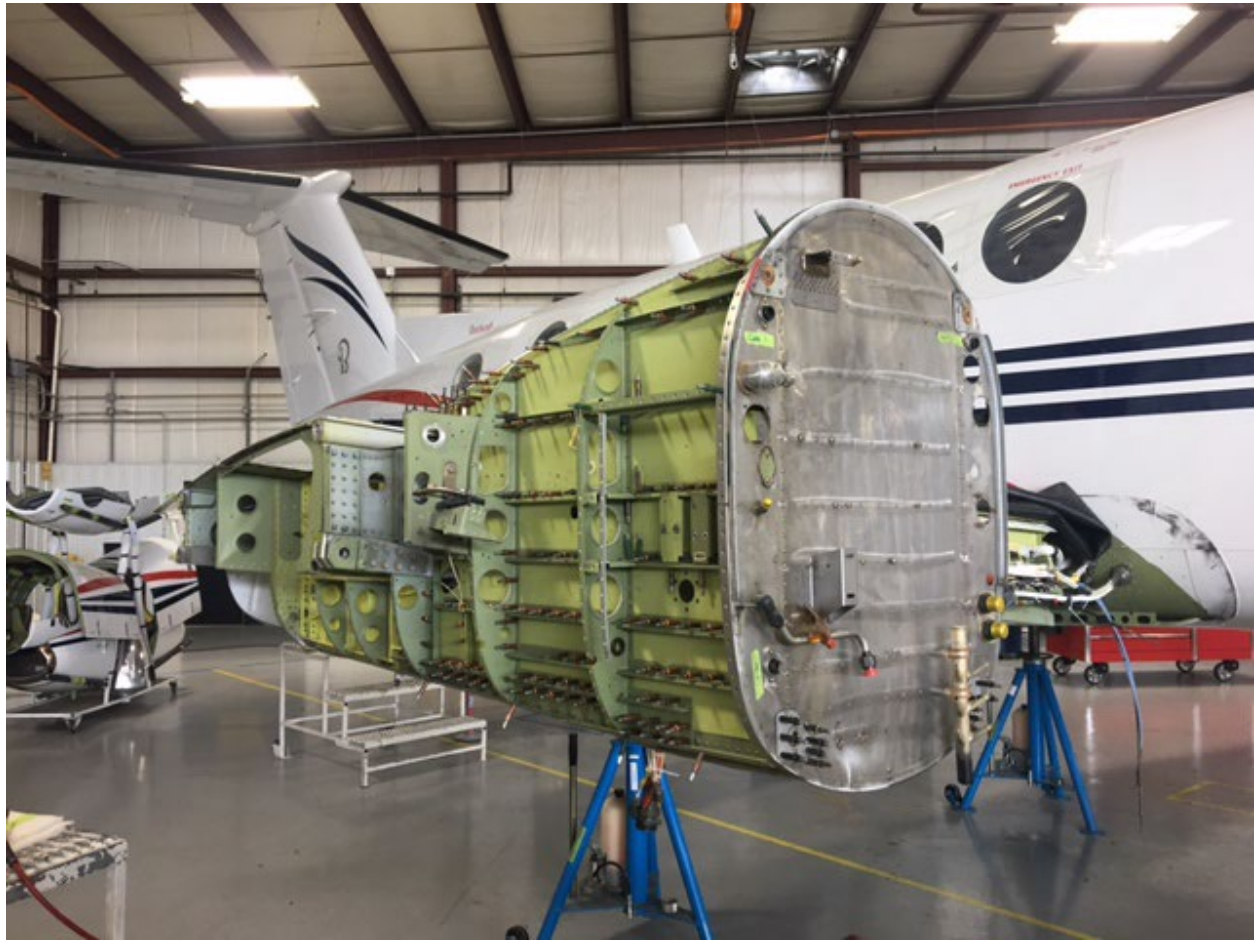
In-Progress Picture.

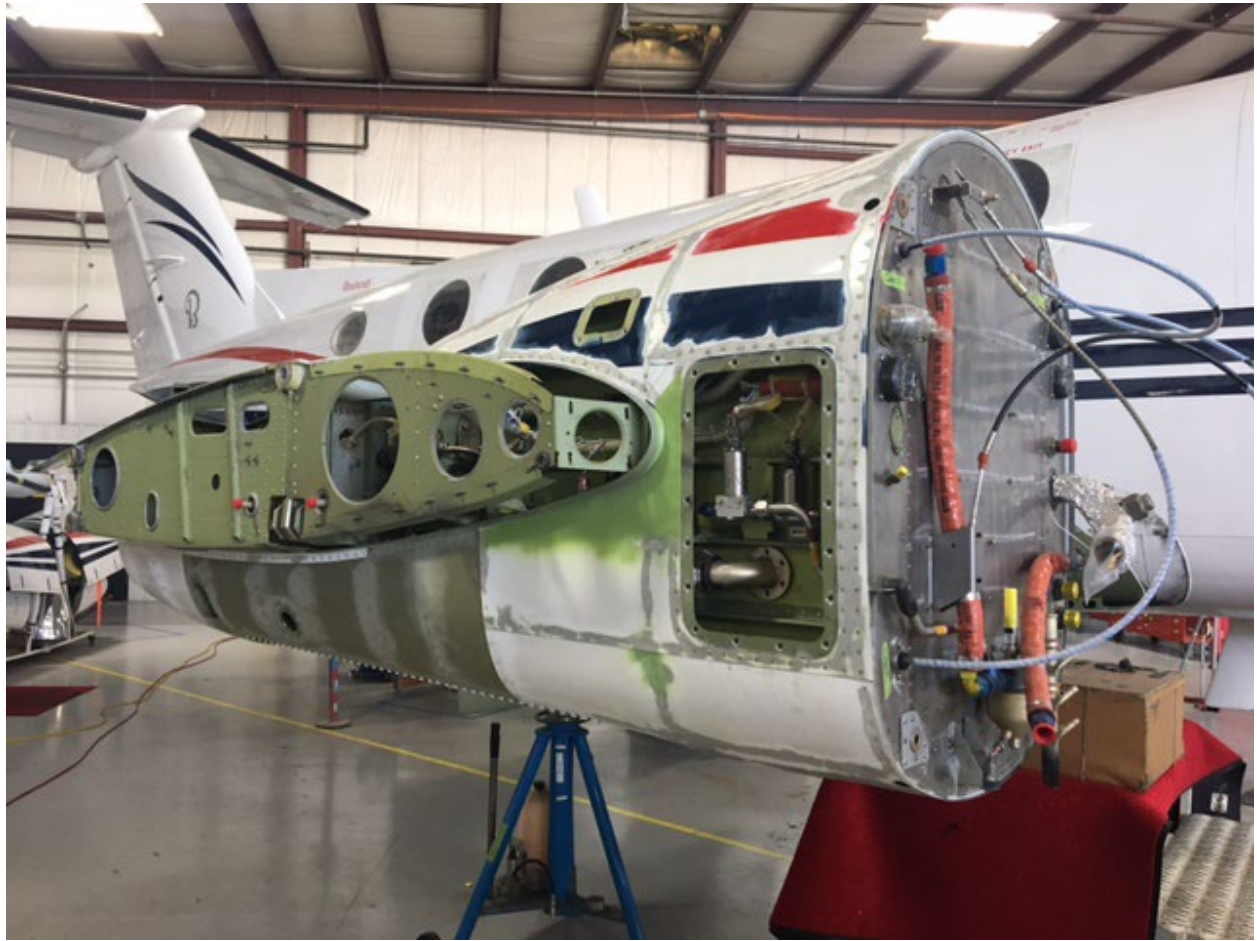
Complete minus engine and wing.

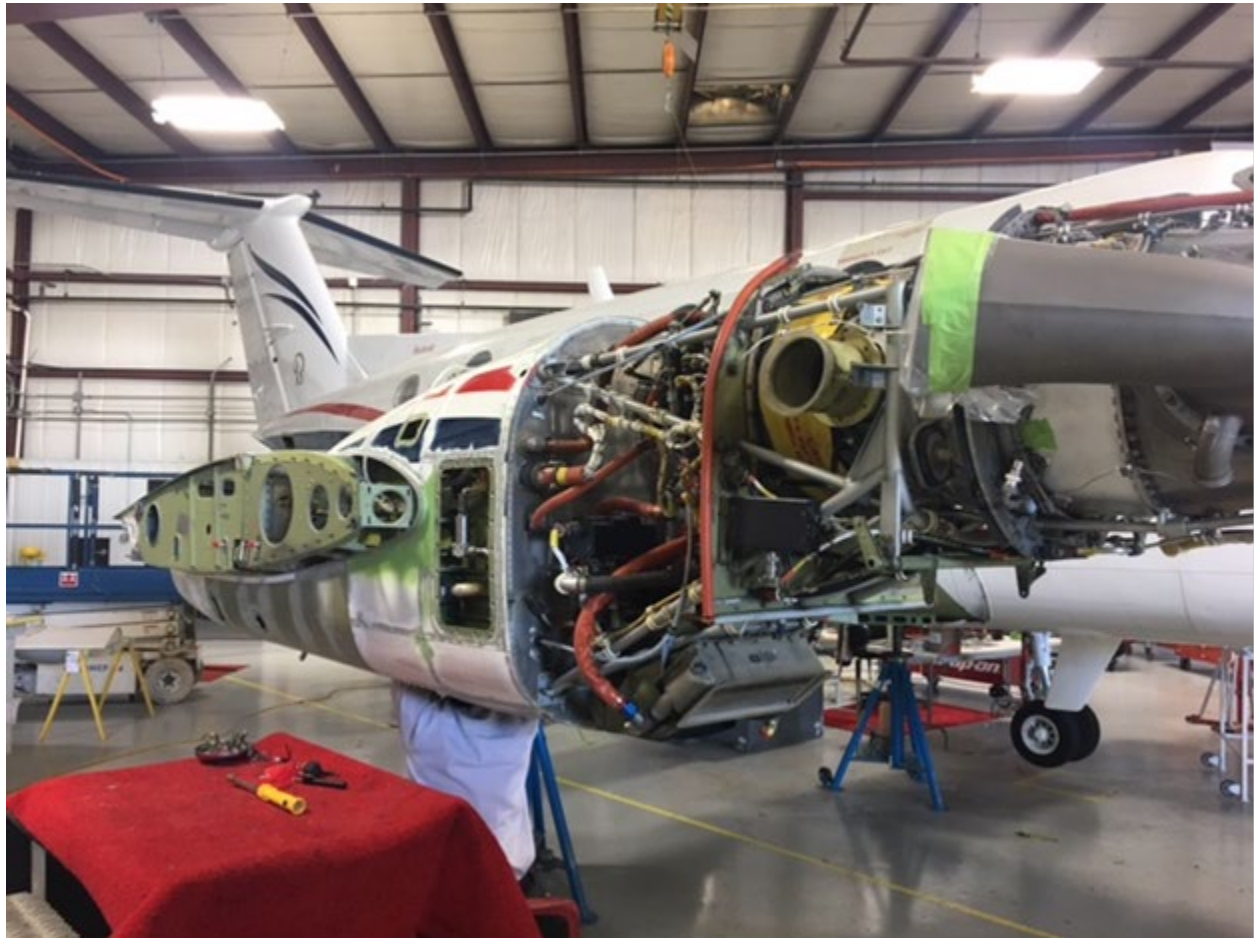
Reassembly. Engine reinstalled and awaiting wing installation 9/6/17.
